# **Reserve Study Level II**

**Prepared for Treasure Island Country Club**

**2021 Fiscal Year**

Prepared by CEDCORE, LLC

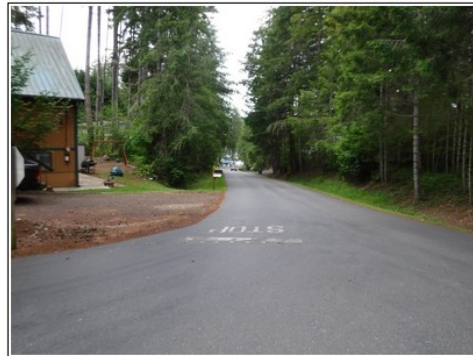
**Site/Grounds - Asphalt: Patch & Resurface**

Location: Various  
 Quantity: 152000 Square Feet  
 UL: 5  
 RUL: 2  
 Current Cost: \$35,100  
 Condition: Assorted Condition  
 Funding Basis: Funded based on the typical life expectancy

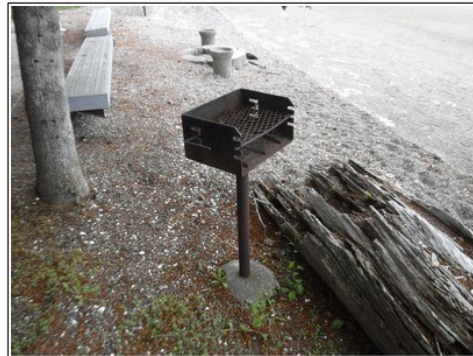
**Recreation - Barbeque**

Location: Beach  
 Quantity: 2 Each  
 UL: 20  
 RUL: 10  
 Current Cost: \$1,200  
 Condition: Good  
 Funding Basis: Funded based on the typical life expectancy

Good condition but will need to be replaced in the future subject to the amount of use. To small an expense to merit reserve funding. Therefore, treat as an operating expense.

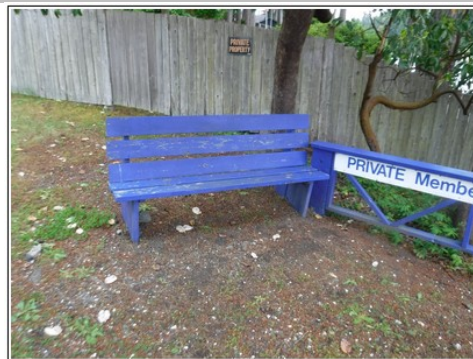
**Recreation - Benches: Replace**

Location: Various  
 Quantity: 4 Each  
 UL: 25  
 RUL: 12  
 Current Cost: \$2,000  
 Condition: Assorted Condition  
 Funding Basis: Funded based on the typical life expectancy

Good condition with no unusual deterioration or instability observed. No history of concern. Repair as needed from the operating budget. Best to plan for total replacement for appearance and functionality.

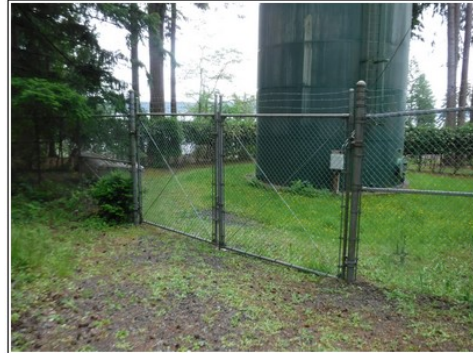
**Site/Grounds - Fence, Chainlink: Replace**

Location: Around Water Tank  
Quantity: 200 Linear Feet  
UL: 40  
RUL: 10  
Current Cost: \$5,600  
Condition: Good  
Funding Basis: Funded based on the typical life expectancy

Good condition of the galvanized chain link fencing. The life expectancy of these units are approximately 40 years. Reserve funding recommended.

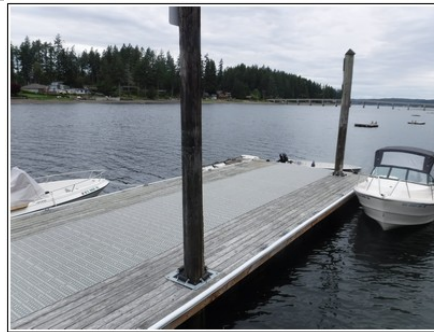
**Recreation - Floating Dock Pilings: Replace**

Quantity: 1 Allowance  
UL: 50  
RUL: 10  
Current Cost: \$16,500  
Condition: Good  
Funding Basis: Funded based on Association direction

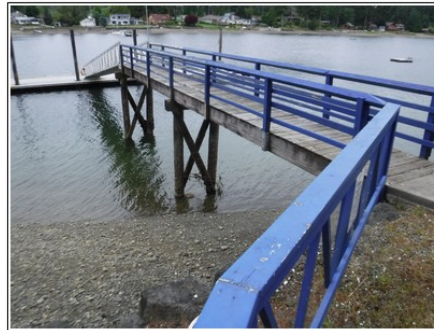
**Site/Grounds - Guardrail, Wood: Replace**

Location: Dock Approach  
 Quantity: 1 Allowance  
 Current Cost:  
 Condition: Assorted Condition  
 Funding Basis: Funded based on the typical life expectancy

In need of repainting as soon as possible to improve appearance and extend life of the wood.

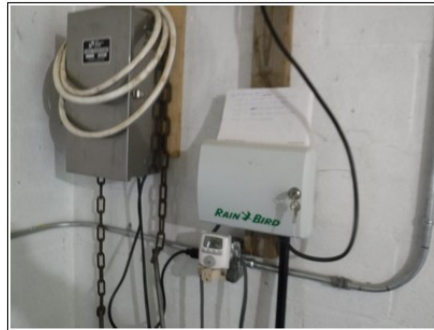
**Site/Grounds - Irrigation System: Repair/Replace**

Current Cost:  
 Condition: Functional  
 Funding Basis: Unfunded operating expense

No known concerns at this time and therefore, no funding has been included. Monitor into the future and adjust as needed. Loss cost components that are best funded from the Operating Budget as needed.

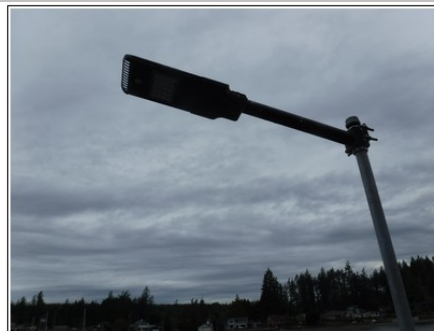
**Site/Grounds - Lights: Pole, Replace**

Quantity: 1 Allowance  
 UL: 30  
 RUL: 15  
 Current Cost: \$2,000  
 Condition: Functional  
 Funding Basis: Funded based on the typical life expectancy

Good condition with no unusual deterioration or instability observed. No history of concern. Repair as needed from the operating budget. Best to plan for total replacement for appearance and functionality.

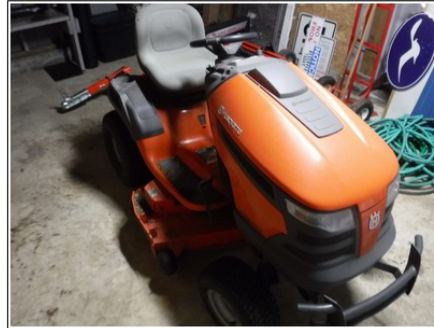
**Mechanical & Equipment - Mower, Husqvarna: Replace**

Quantity: 1 Each  
 UL: 15  
 RUL: 3  
 Current Cost: \$2,930  
 Condition: Fair  
 Funding Basis: Funded based on the typical life expectancy

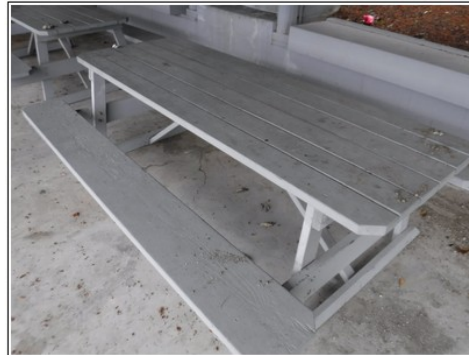
**Recreation - Picnic Table: Replace**

Location: Beach  
 Quantity: 2 Each  
 UL: 25  
 RUL: 12  
 Current Cost: \$3,200  
 Condition: Good  
 Funding Basis: Funded based on the typical life expectancy

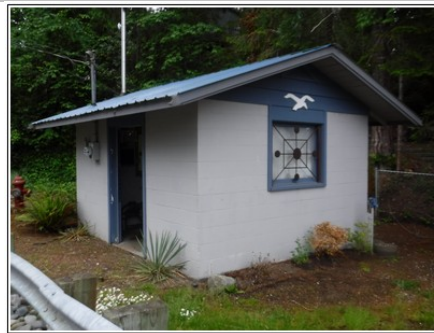
### Building Exterior - Pumphouses: Repairs

Location: Various  
 Quantity: 3 Each  
 UL: 3  
 RUL: 3  
 Current Cost: \$3,000  
 Condition: Assorted Condition  
 Funding Basis: Funded for repair

Funded for miscellaneous repairs or maintenance of the pumphouses as needed.

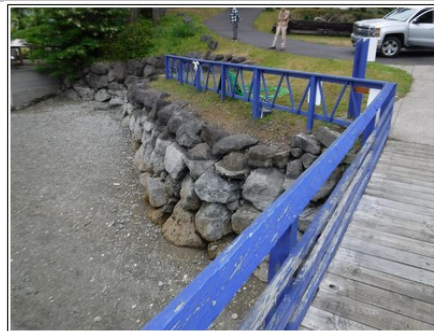
### Site/Grounds - Rock Bulkhead: Repairs

Location: Beach  
 Quantity: 1 Allowance  
 UL: 40  
 RUL: 20  
 Current Cost: \$29,800  
 Condition: Fair  
 Funding Basis: Funded based on Association direction

Fair condition with no known instability or concerns identified. Should conditions change, we recommend a thorough evaluation be conducted by a qualified geotechnical engineer.

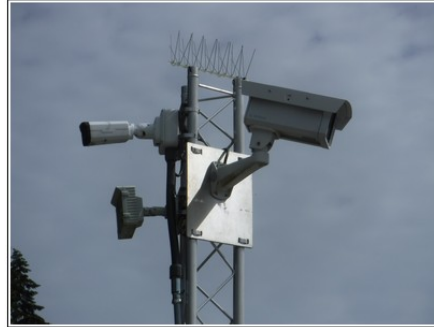
### Building - Security System Upgrade

Quantity: 1 Allowance  
 UL: 5  
 RUL: 3  
 Current Cost: \$15,000  
 Condition: Good  
 Funding Basis: Funded based on Association direction

This component may be used to fund partial replacement as needed. These systems typically become technologically obsolete before they become nonfunctional.

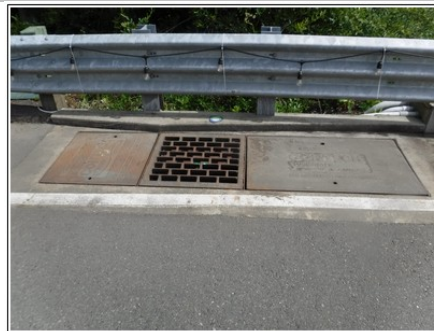
### Mechanical & Equipment - Storm Water Catch Basins: Clean Sump & Replace Canisters

Quantity: 1 Allowance  
 UL: 3  
 RUL: 0  
 Current Cost: \$3,200  
 Condition: Good  
 Funding Basis: Funded based on the typical life  
 expectancy

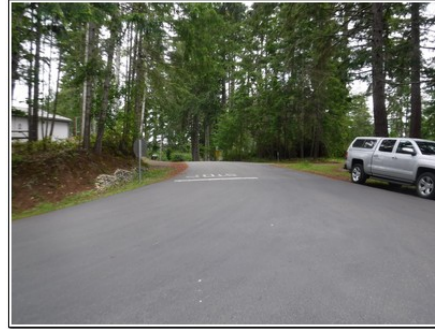
### Site/Grounds - Tree Analysis & Disposition

Quantity: 1 Allowance  
 RUL: 0  
 Current Cost: \$7,470  
 Condition: Assorted Condition  
 Funding Basis: Funded based on Association direction
